Manhole Inspection Summary

Manhole # S37MM_019MH

Insp Date: 1/31/07 12:22 PM

Location Address: **406 21ST ST**

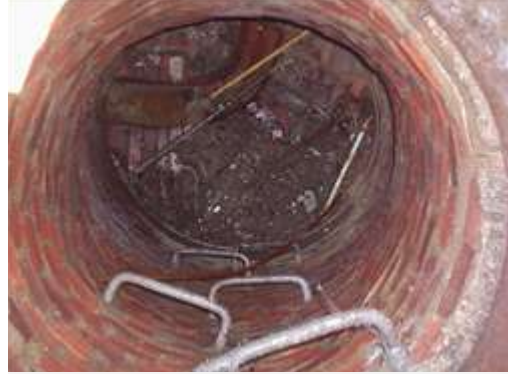
Top View

Barrel infiltration. Evidence of surcharge - Bench debris. Channel debris.

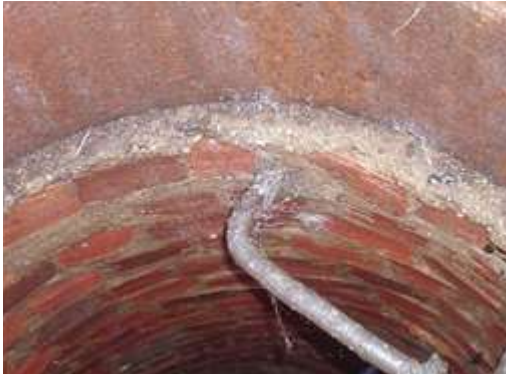
Defect

Frame leaks. Frame offset. Adjustment and Corbel infiltration.

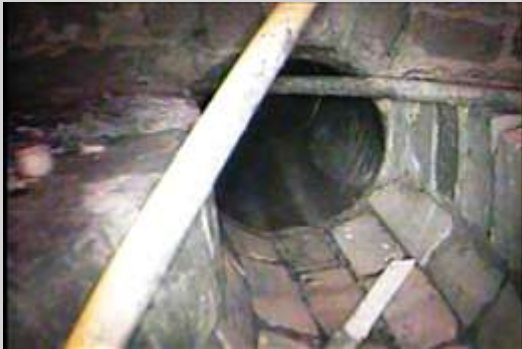
8 in. Circular Gravity Sewer Pipe Out @ 12 O'Clock

Infiltration: **Evidence** Pipe Seal Cond: **Unknown**
